Subject: New upper isolator - Refer to TSBCL2010-12 for related Boost Deck & Isolator Improvements.

Models Affected: Focus II Boost L20 (all models)

Subject: BOOST Flex Plate, Bearing Shield & Isolator Replacement - Revised to reflect change in 20" Upper Isolator and Nut, and further improvements to the Flex Plate mounting. Refer to TSBCL2010-21

Models Affected: BOOST 28 BOOST 32 (05312K, 05313K) Focus BOOST Rider (00344K) Focus II BOOST L20 (05370A-S) Focus II MID-SIZE BOOST 28 & 32

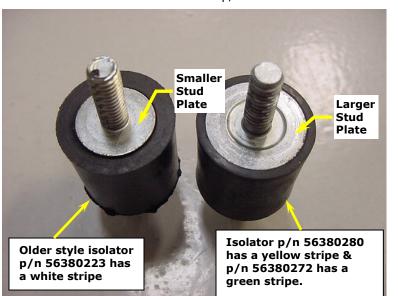
Issue: Premature isolator failure during assembly or at low hours

Cause: Inadequate bond between rubber body and stud plate

Corrective Action: Factory: Effective 6/17/10 with SN 8000025674, Isolator p/n 56380223 was replaced with p/n 56380280 which had a larger stud plate (See Figure 1 below). As a further enhancement on 7/12/10 and with SN 8000027901, isolator p/n 56380272 made from a neoprene vs. rubber material replaced 56380280.

Field: If you experience a premature isolator failure, replace the older style Isolator with p/n 56380280 or 56380272.

- **1.** Apply Loctite to the bottom threads on the Isolator and hand-tighten into the deck.
- **2.** Apply Loctite to the nut on the Isolator top threads and toraue the nut to 8-10 in-lbs / 10.8-13.5 Nm.

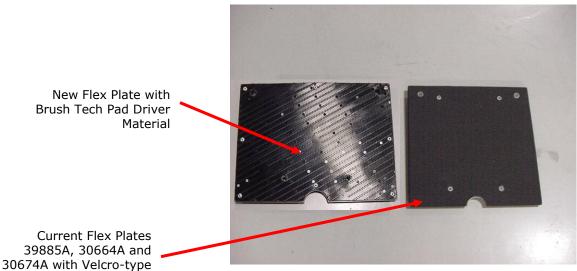
Figure 1 – Current vs. New Style Flex Plate

- 1. Velcro-type pad driver failure. When exposed to certain chemicals, the adhesive holding the Velcrotype pad driver material to the flex plate could weaken and potentially delaminate.

- 1. A new flex plate assembly was implemented with the following improvements:
 - a. Switched to a nylon pad driver material with "harpoon" style barbs (eliminated the fabric Velcro-type material)

- b. Mechanically securing the pad driver material via rivets
- 2. The bearing assembly was updated with the following changes:
 - a. Using an improved molded plastic bearing shield to deflect water away from the bearing. The new bearing shield uses a significantly more durable material and a tighter assembly fit for better retention and durability than the previous version.

1. If premature separation between the Velcro-type pad driver material and flex plate is observed on machines with serial numbers prior to those listed in the above table, replace the flex plate with the flex plate kits noted on page 7.

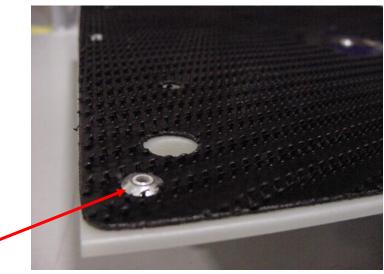
Figure 2 – New (Brush Tech) Pad Driver Material (Page 3 of 10)

Thicker material allows use of rivets to improve connection between Pad Driver Material and Flex Plate.

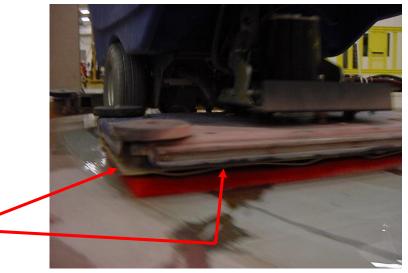
Figure 3 – Adhesive on New Flex Plate

Under certain conditions the adhesive on the new Flex Plate may break down and release along the edges, but this does not affect functionality. The additional rivet fastening maintains integrity and keeps the Pad Driver Material secured to the Flex Plate.

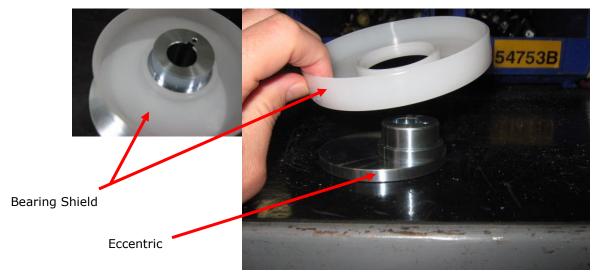
Figure 6 – Bearing Shield Assembly

- 2. Shortened bearing life:
 - a. The bearing shield can come loose, exposing the bearing to water. This exposure can eventually result in moisture working its way into the bearing, causing bearing wear or even eventually causing the bearing to seize.

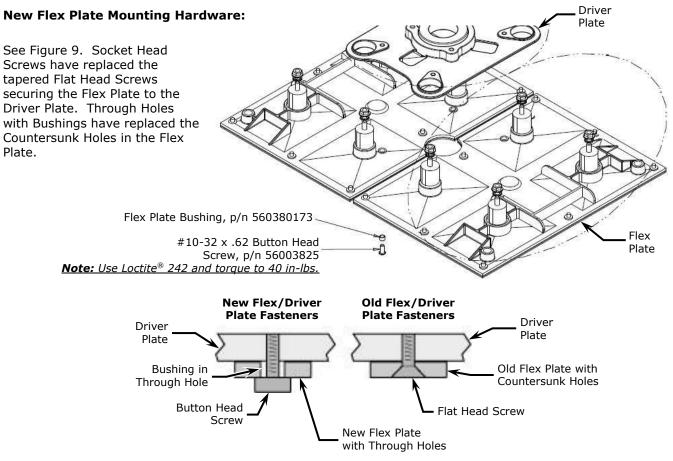
Figure 9 – New Flex Plate Mounting Hardware

- 4. Vibration results in wear between the flex plate and screw head.

4. The flex plate was redesigned to utilize a bushing and socket head screw vs. a tapered flat head screw to secure the flex plate to the driver plate. This change was implemented on all models as noted in the table below and on all kits effective 6/23/10.

Note: If you order a new Flex Plate, you'll need to order new fasteners:

- Flex Plate Bushing, p/n 560380173
- #10-32 x .62 Button Head Socket Screw, SS, p/n 56003825

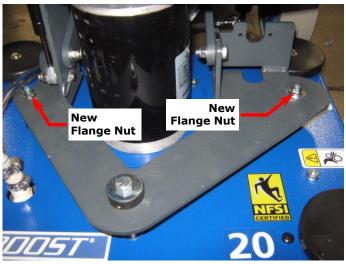
Figure 19 – Scrub Deck Assembled to Mounting Bracket (20" Deck shown)

- b. If excessive torque is applied during isolator installation the isolators can be twisted and effectively pre-loaded, which can result in diminished performance and the potential for premature wear and / or failure.

- d. Adjusted assembly process to reduced torque specification to prevent isolator twisting.
 - e. Locknut, p/n 920110, was replaced with a flange nut, p/n 81211A, to further reduce the potential of twisting the isolator during installation (see Figure 19). The upper isolator on the 20" machines was revised. Refer to TSBCL2010-21 for details.

Step 8Assemble the Scrub Deck to the
Mounting Bracket.

Torque nuts to 8-10 ft-lbs. Look at the lines on the upper isolators and make sure they are not twisted, which indicates they are over tightened.
