Subject: New upper isolator - Refer to TSBCL2010-12 for related Boost Deck & Isolator Improvements.

Models Affected: Focus II Boost L20 (all models)

Subject: BOOST Flex Plate, Bearing Shield & Isolator Replacement - Revised to reflect change in 20" Upper Isolator and Nut, and further improvements to the Flex Plate mounting. Refer to TSBCL2010-21

Models Affected: BOOST 28 BOOST 32 (05312K, 05313K) Focus BOOST Rider (00344K) Focus II BOOST L20 (05370A-S) Focus II MID-SIZE BOOST 28 & 32

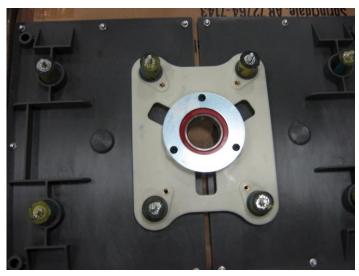
Figure 12 – Fastening the Flex Plate(s) to the Driver Plate

4. The flex plate was redesigned to utilize a bushing and socket head screw vs. a tapered flat head screw to secure the flex plate to the driver plate. This change was implemented on all models as noted in the table below and on all kits effective 6/23/10.

3. If premature wear occurs at the flex plate mounting, replace with the new plate and hardware.
